## APPENDIX Q - AQUATIC ECOLOGY ASSESSMENT

# **Isaac Downs Extension Project Aquatic Ecology Assessment**

**Prepared for  
Stanmore ID Extension Pty Ltd  
2026**

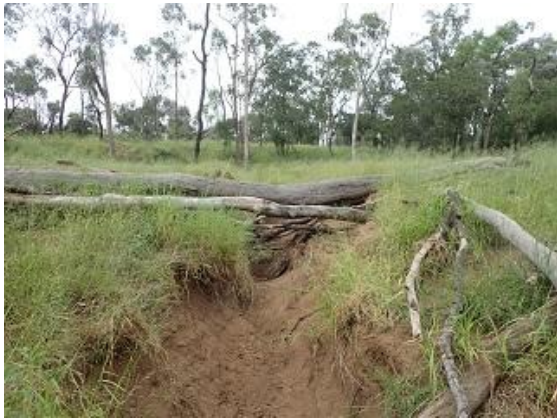
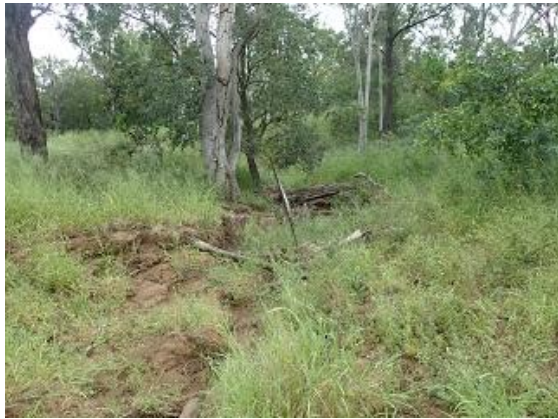
| AH1<br>Unnamed creek<br>18/3/2025 | | Co-ordinates (UTM 55K)<br>E 618950<br>S 7561392 | |

| AH1<br>Unnamed creek<br>18/3/2025 | | Co-ordinates (UTM 55K)<br>E 618950<br>S 7561392 | |
|---|---|---|---|
| <b>Comments:</b> Dry site, unlikely to hold water for extended periods immediately following heavy rainfall. | | | |

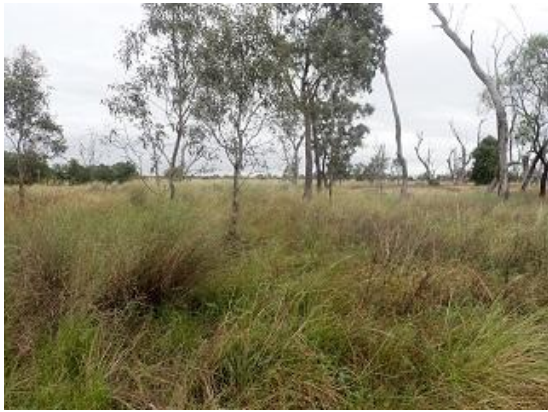
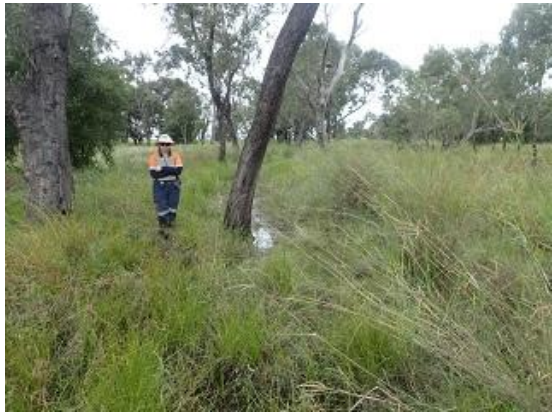
| <p align="center"><b>Channel characteristics</b></p> <table> <tr><td>Reach length</td><td>100 m</td></tr> <tr><td>Bankfull bank height</td><td>0.2 m</td></tr> <tr><td>Bankfull stream width</td><td>10 m</td></tr> <tr><td>Mean water depth</td><td>0.02 m</td></tr> <tr><td>Maximum water depth</td><td>0.05 m</td></tr> <tr><td>Mean wetted width</td><td>1.0 m</td></tr> </table> | Reach length | 100 m | Bankfull bank height | 0.2 m | Bankfull stream width | 10 m | Mean water depth | 0.02 m | Maximum water depth | 0.05 m | Mean wetted width | 1.0 m | <p align="center"><b>Mesohabitat composition</b></p> <table> <tr><td>Riffle</td><td>-</td></tr> <tr><td>Run</td><td>-</td></tr> <tr><td>Shallow pool (&lt;1m)</td><td>10 %</td></tr> <tr><td>Deep pool (&gt;1m)</td><td>-</td></tr> <tr><td>Dry</td><td>90 %</td></tr> </table> | Riffle | - | Run | - | Shallow pool (<1m) | 10 % | Deep pool (>1m) | - | Dry | 90 % | | | | | | | | | | | | |

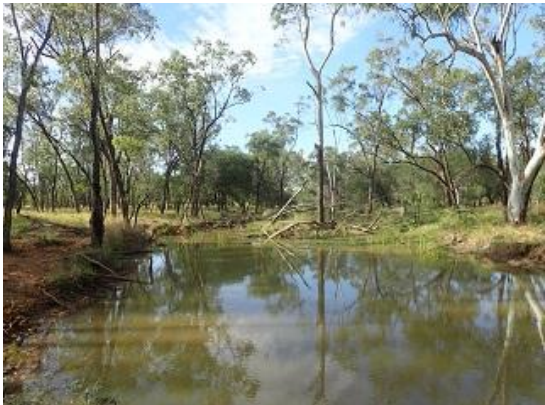
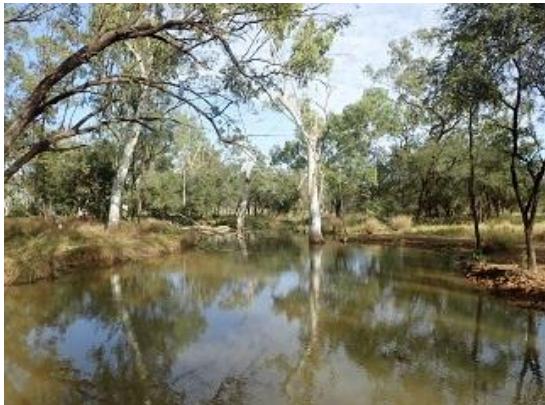
| AH5<br>JB Gully<br>1/5/2025 | | Co-ordinates (UTM 55K)<br>E 621079<br>S 7551949 | |

| AH5<br>JB Gully<br>1/5/2025 | | Co-ordinates (UTM 55K)<br>E 621079<br>S 7551949 | |
|---|---|---|---|
| <b>Comments:</b> Likely to be one of the last pools in the area to dry up. | | | |

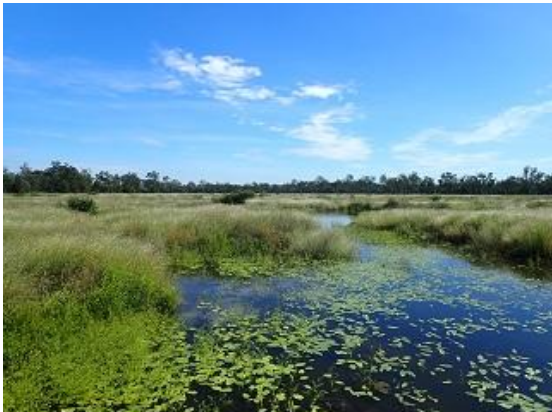
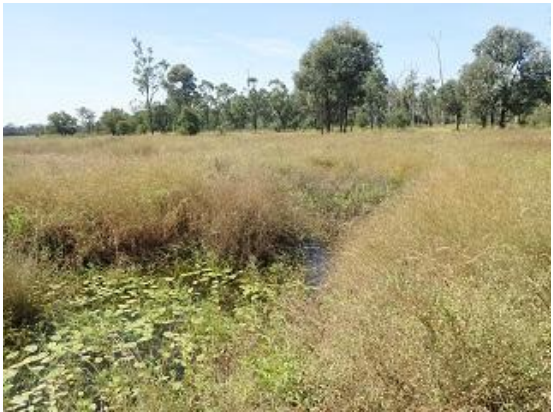
| AH7<br>Unnamed gilgai<br>1/5/2025 | | Co-ordinates (UTM 55K)<br>E 625932<br>S 7553596 | |

| AH7<br>Unnamed gilgai<br>1/5/2025 | | Co-ordinates (UTM 55K)<br>E 625932<br>S 7553596 | |
|---|---|---|---|
| <b>Comments:</b> Inspected as possible aquatic habitat. The pool sampled was the largest but part of a much wider network of gilgais. | | | |

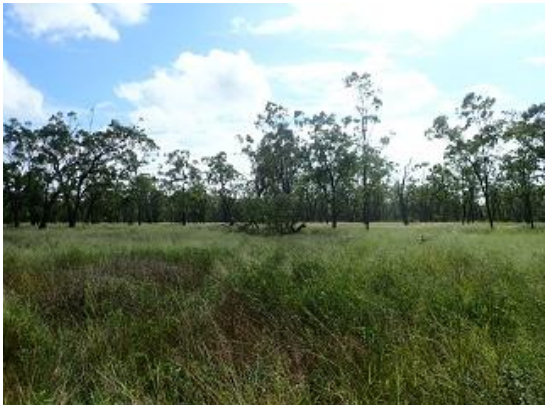
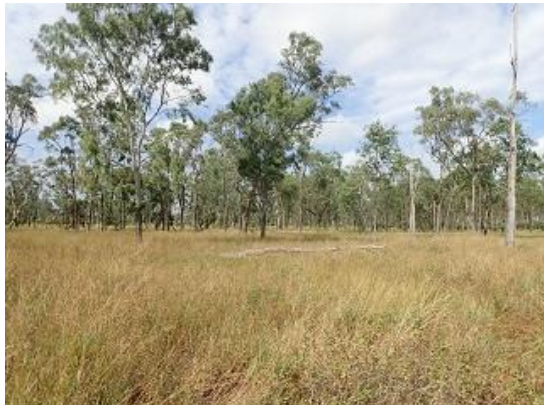
| AH8<br>Unnamed depression<br>2/5/2025 | | Co-ordinates (UTM 55K)<br>E 618673<br>S 7554144 | |

| AH8<br>Unnamed depression<br>2/5/2025 | | Co-ordinates (UTM 55K)<br>E 618673<br>S 7554144 | |
|---|---|---|---|
| <b>Comments:</b> Inspected as possible aquatic habitat. Unlikely to hold water. Not a waterbody. | | | |

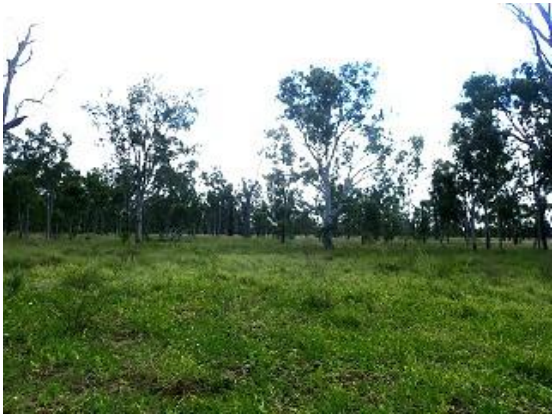
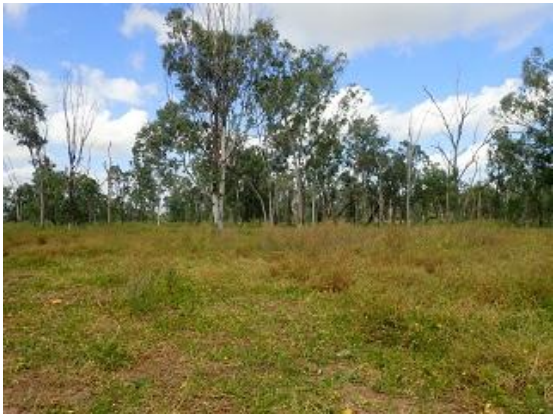
| AH9<br>Unnamed depression<br>2/5/2025 | | Co-ordinates (UTM 55K)<br>E 619585<br>S 7554560 | |

| AH9<br>Unnamed depression<br>2/5/2025 | | Co-ordinates (UTM 55K)<br>E 619585<br>S 7554560 | |
|---|---|---|---|
| <b>Comments:</b> Inspected as possible aquatic habitat. Unlikely to hold water. Not a waterbody. | | | |

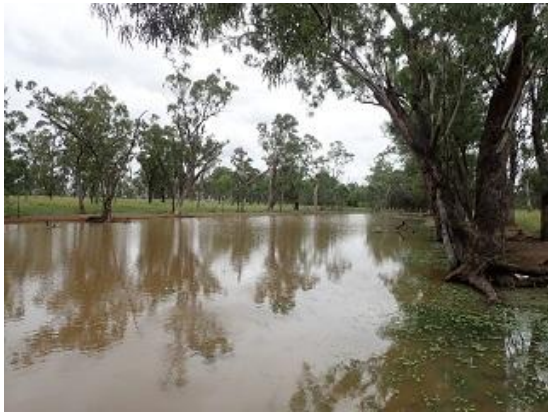
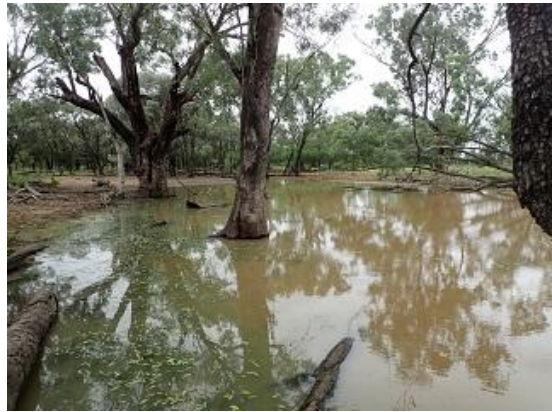
| <p align="center"><b>Channel characteristics</b></p> <table> <tr><td>Reach length</td><td>100 m</td></tr> <tr><td>Bankfull bank height</td><td>1.0 m</td></tr> <tr><td>Bankfull stream width</td><td>50 m</td></tr> <tr><td>Mean water depth</td><td>0.4 m</td></tr> <tr><td>Maximum water depth</td><td>0.8 m</td></tr> <tr><td>Mean wetted width</td><td>20 m</td></tr> </table> | Reach length | 100 m | Bankfull bank height | 1.0 m | Bankfull stream width | 50 m | Mean water depth | 0.4 m | Maximum water depth | 0.8 m | Mean wetted width | 20 m | <p align="center"><b>Mesohabitat composition</b></p> <table> <tr><td>Riffle</td><td>-</td></tr> <tr><td>Run</td><td>-</td></tr> <tr><td>Shallow pool (&lt;1m)</td><td>90 %</td></tr> <tr><td>Deep pool (&gt;1m)</td><td>-</td></tr> <tr><td>Dry</td><td>10 %</td></tr> </table> | Riffle | - | Run | - | Shallow pool (<1m) | 90 % | Deep pool (>1m) | - | Dry | 10 % | | | | | | | | | | | | |

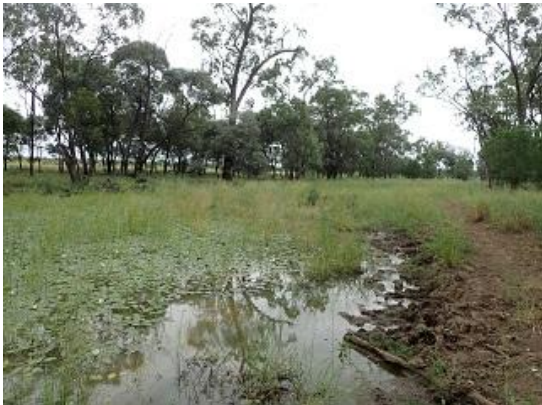
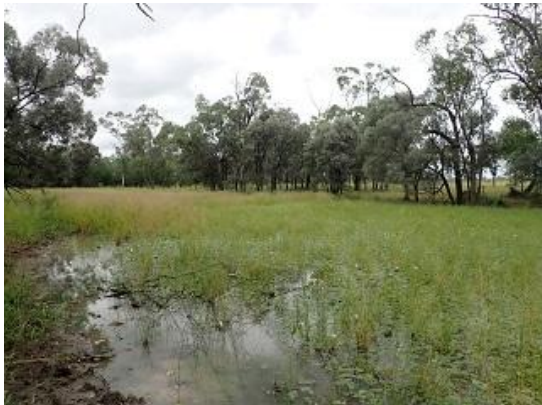
| <b>AH12</b><br><b>Unnamed wetland</b><br><b>18/3/2025</b> | | <b>Co-ordinates (UTM 55K)</b><br><b>E 621300</b><br><b>S 7560140</b> | |

| <b>AH12</b><br><b>Unnamed wetland</b><br><b>18/3/2025</b> | | <b>Co-ordinates (UTM 55K)</b><br><b>E 621300</b><br><b>S 7560140</b> | |
|---|---|---|---|
| <b>Comments:</b> A small wetland was present with well established macrophytes. No other wetlands were present immediately upstream or downstream of this point | | | |

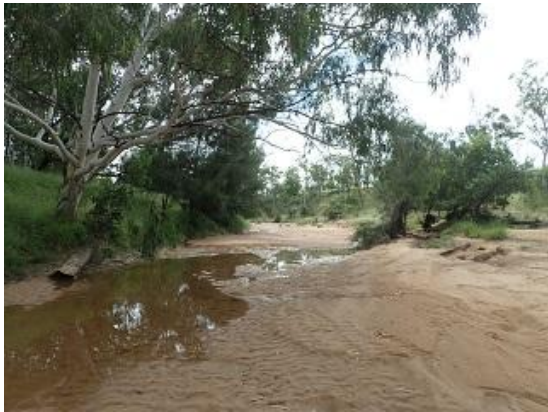
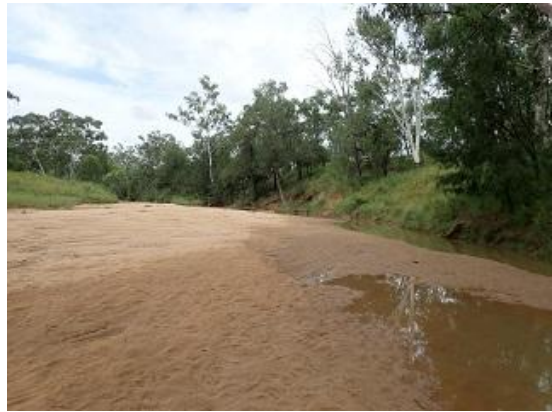
| <p style="text-align: center;"><b>Channel characteristics</b></p> <table> <tr><td>Reach length</td><td>100 m</td></tr> <tr><td>Bankfull bank height</td><td>7 m</td></tr> <tr><td>Bankfull stream width</td><td>25 m</td></tr> <tr><td>Mean water depth</td><td>0.4 m</td></tr> <tr><td>Maximum water depth</td><td>1.0 m</td></tr> <tr><td>Mean wetted width</td><td>2.5 m</td></tr> </table> | Reach length | 100 m | Bankfull bank height | 7 m | Bankfull stream width | 25 m | Mean water depth | 0.4 m | Maximum water depth | 1.0 m | Mean wetted width | 2.5 m | <p style="text-align: center;"><b>Mesohabitat composition</b></p> <table> <tr><td>Riffle</td><td>-</td></tr> <tr><td>Run</td><td>-</td></tr> <tr><td>Shallow pool (&lt;1m)</td><td>80 %</td></tr> <tr><td>Deep pool (&gt;1m)</td><td>-</td></tr> <tr><td>Dry</td><td>20 %</td></tr> </table> | Riffle | - | Run | - | Shallow pool (<1m) | 80 % | Deep pool (>1m) | - | Dry | 20 % | | | | | | | | | | | | |

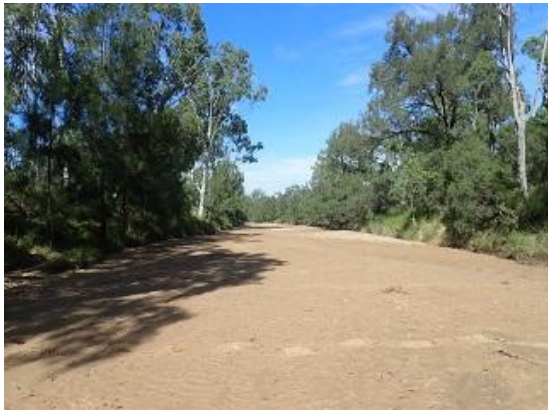
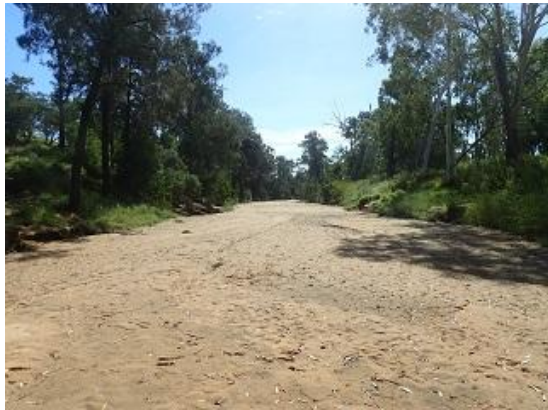
| <b>AQ5</b><br><b>Cherwell Creek</b><br><b>1/5/2025</b> | | <b>Co-ordinates (UTM 55K)</b><br><b>E 621049</b><br><b>S 7553251</b> | |

| <b>AQ5</b><br><b>Cherwell Creek</b><br><b>1/5/2025</b> | | <b>Co-ordinates (UTM 55K)</b><br><b>E 621049</b><br><b>S 7553251</b> | |
|---|---|---|---|
| <b>Comments:</b> Dry site, no signs of water persistence. | | | |

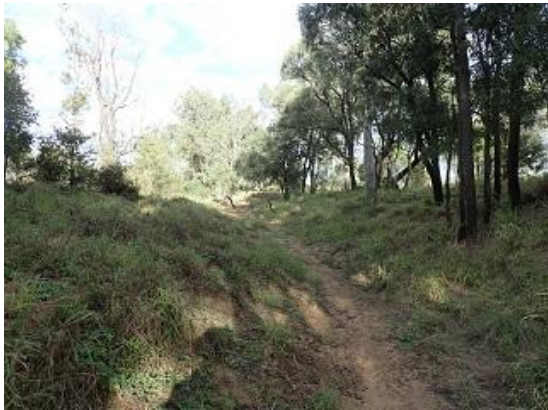
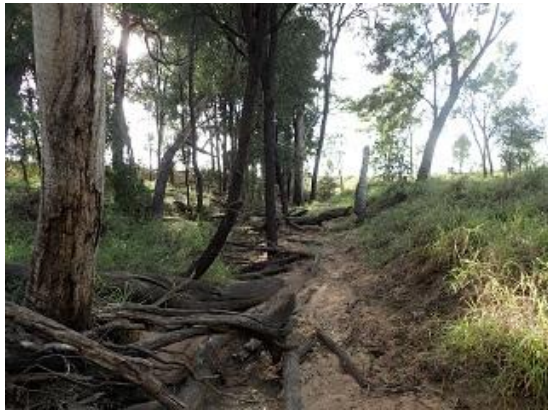
| <b>AQ8</b><br><b>Conrock Gully</b><br><b>20/7/2025</b> | | <b>Co-ordinates (UTM 55K)</b><br><b>E 620889</b><br><b>S 7556282</b> | |

| <b>AQ8</b><br><b>Conrock Gully</b><br><b>20/7/2025</b> | | <b>Co-ordinates (UTM 55K)</b><br><b>E 620889</b><br><b>S 7556282</b> | |
|---|---|---|---|
| <b>Upstream</b> | | <b>Downstream</b> | |

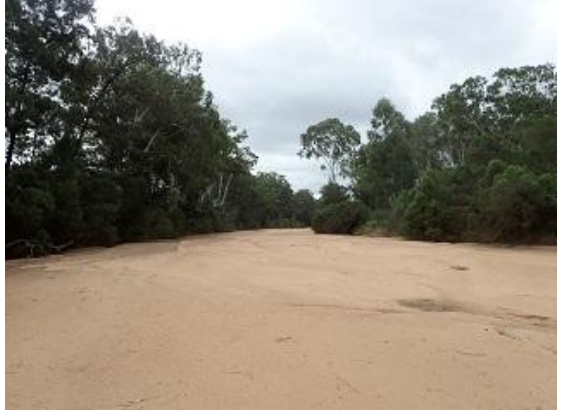
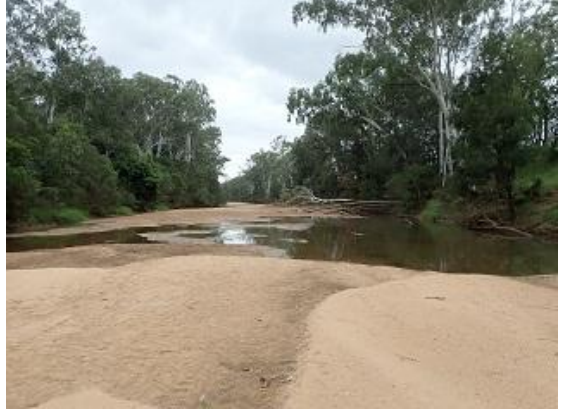
| <p style="text-align: center;"><b>Upstream</b></p> | <p style="text-align: center;"><b>Downstream</b></p> | | | | | | | | | | | | | | | | | | | | | | | | | | | | | | | | | | |

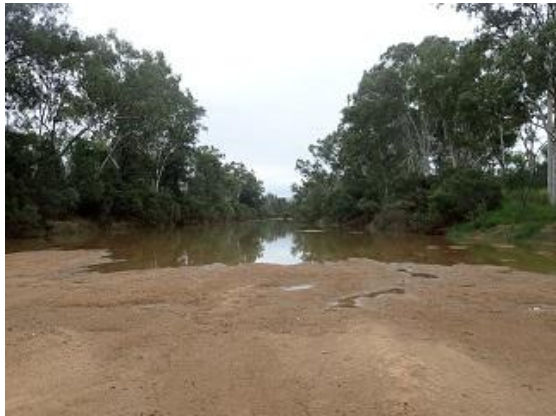
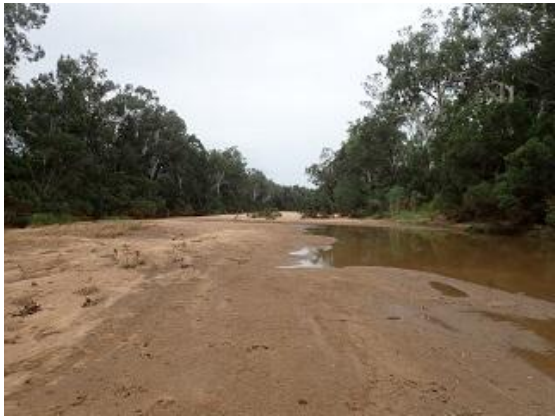
| <b>AQ10</b><br><b>Isaac River</b><br><b>18/3/2025</b> | | <b>Co-ordinates (UTM 55K)</b><br><b>E 619807</b><br><b>S 7562136</b> | |

| <b>AQ10</b><br><b>Isaac River</b><br><b>18/3/2025</b> | | <b>Co-ordinates (UTM 55K)</b><br><b>E 619807</b><br><b>S 7562136</b> | |
|---|---|---|---|
| <b>Upstream</b> | | <b>Downstream</b> | |
| <b>Comments:</b> A large pool upstream extends for several hundred metres. Some low flow in sections becoming hyporheic in other sections. | | | |

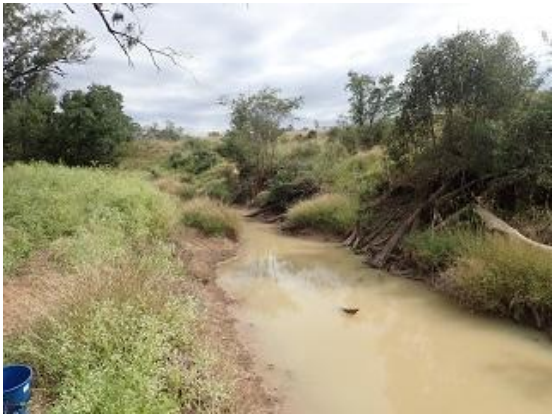
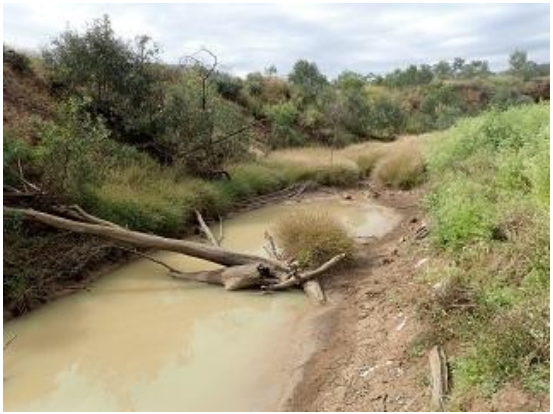
| <b>AQ11</b><br><b>Conrock Gully</b><br><b>22/7/2025</b> | | <b>Co-ordinates (UTM 55K)</b><br><b>E 624064</b><br><b>S 7557839</b> | |

| <b>AQ11</b><br><b>Conrock Gully</b><br><b>22/7/2025</b> | | <b>Co-ordinates (UTM 55K)</b><br><b>E 624064</b><br><b>S 7557839</b> | |
|---|---|---|---|
| <b>Upstream</b> | | <b>Downstream</b> | |
